Einsteins V2.4004:  
resonance adventure:  
300 trident machine

Ebb36 v1.2

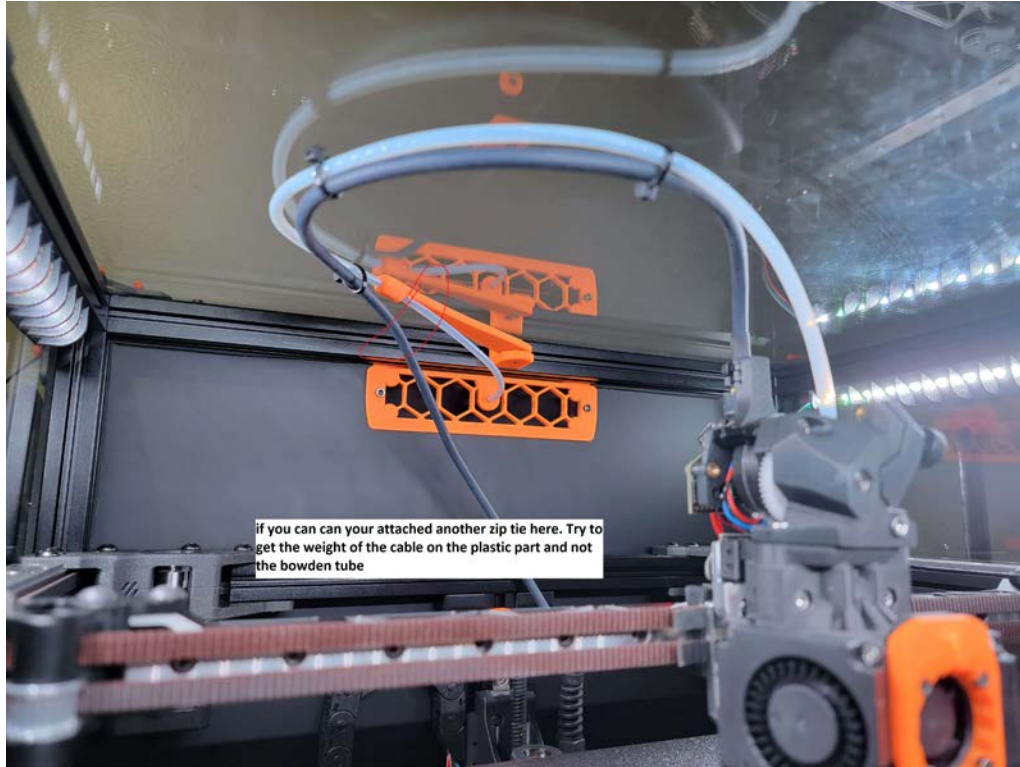
# Recommended securing canbus cable better

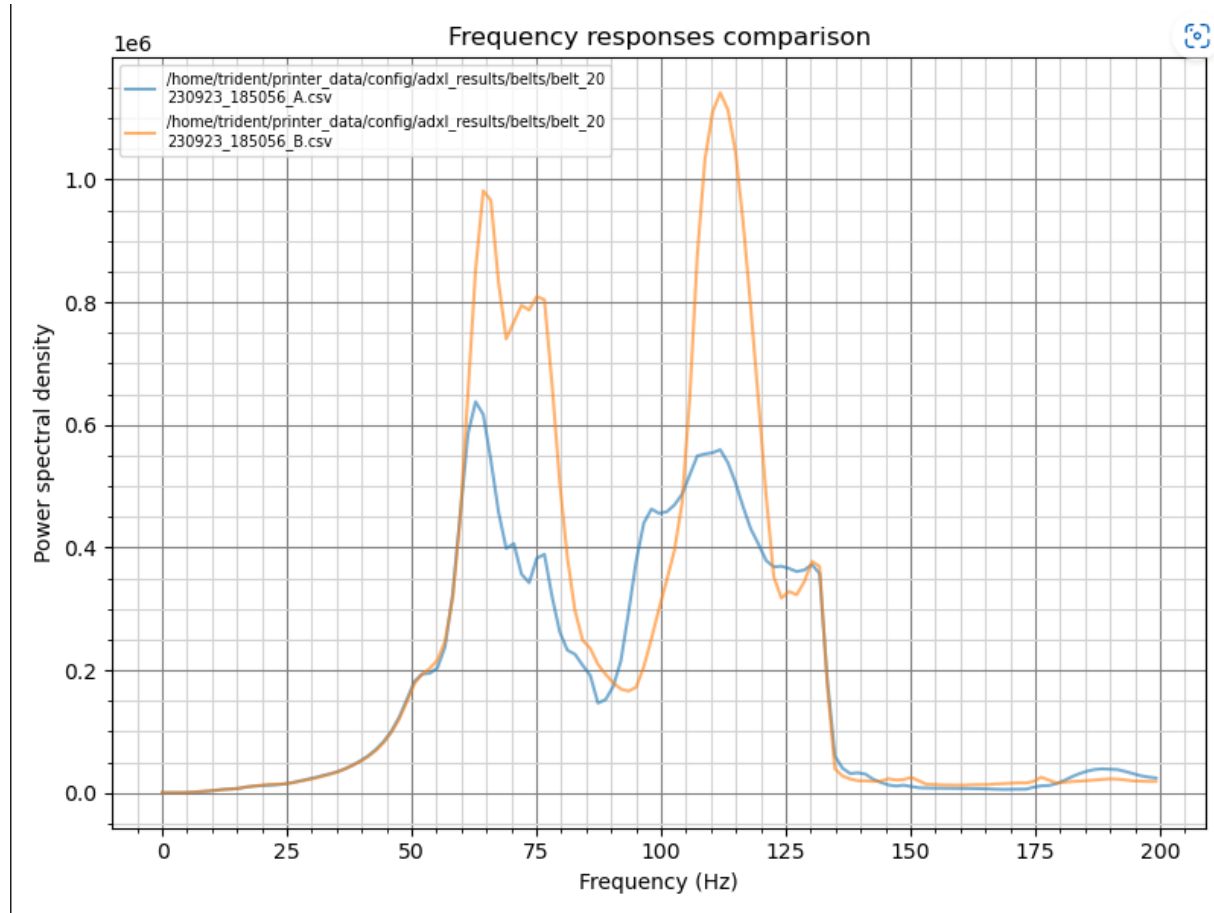
Original

# Loosen belts by $\frac{1}{2}$ turn to see if second peak dies down

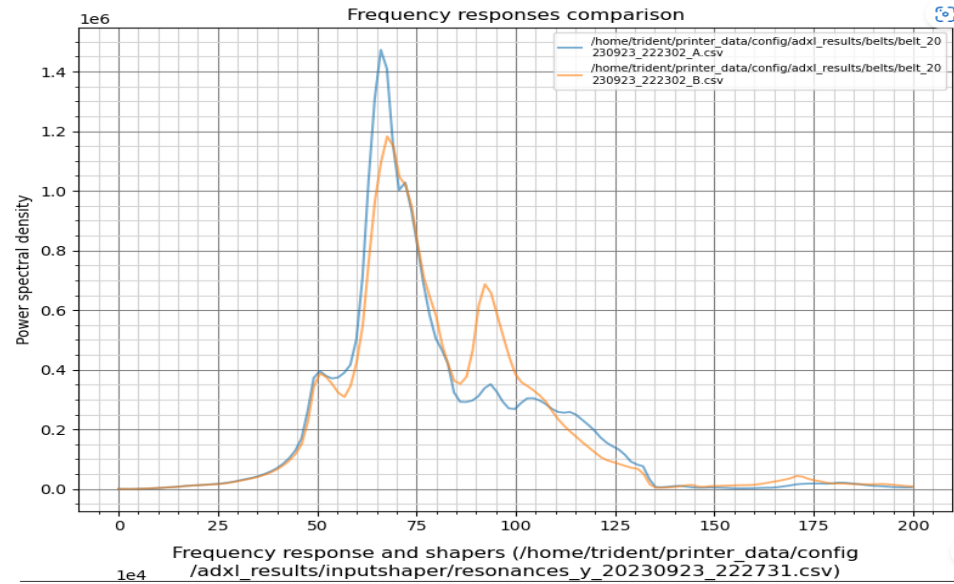
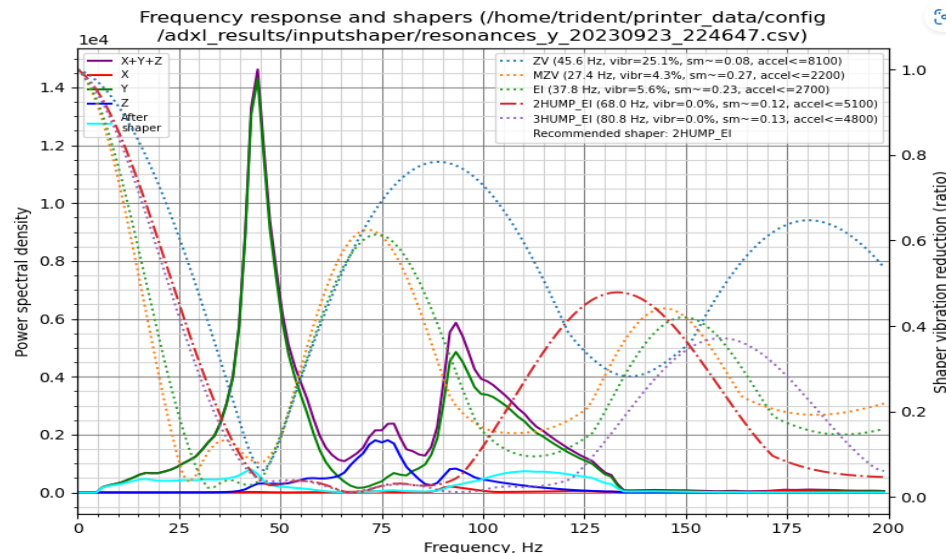
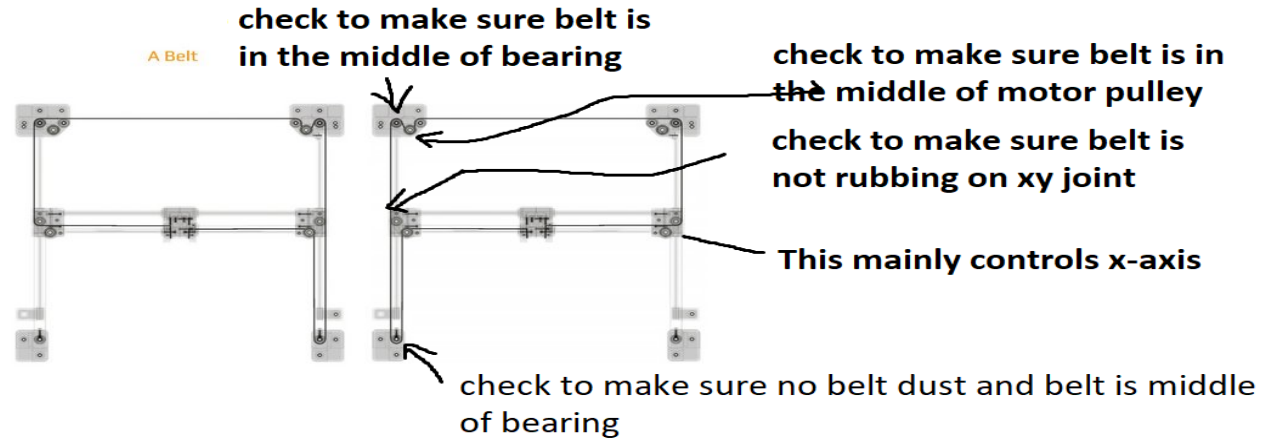
# The Attack Plan...

Comparing these two graphs we see that they have a common spike around 100Hz. In the belt shaper it is on the B belt. Above is a picture of the belt paths.

Based upon the data from this y-graph,

I think something in your b-belt path is the cause. What I would do is take the panels off and run a speed test. Watch the B-belt move and see what happens. I would also be listening to the y-linear rails and see if they sound good.

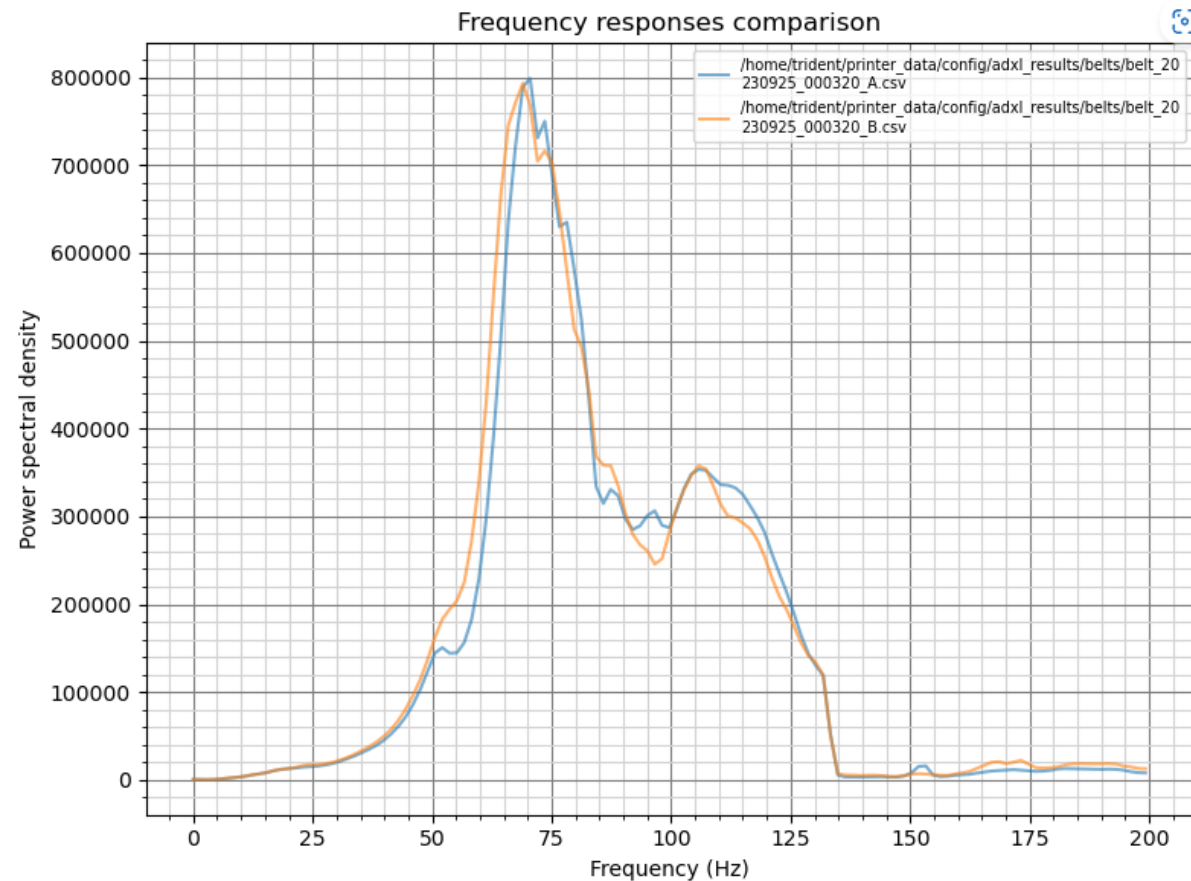
- When assembling the CNC XY Joints I put together the bearings in the same Stack configuration as a stock XY joint.  
This was incorrect and ended up with 1 additional 1mm washer in one of the bearing stacks.  
This caused the joint to not properly fit together and put a lot of additional pressure on the bearing pins.
- Disassembled the gantry and Fixed Bearing stacks (1 on each side)
- De-racked the gantry
- Reassembled remaining Gantry components and ran motion test
- Re-tensioned belts to between 108hz and 110hz
- Adjusted belt using Belt Shaper to get the following result

# Belt shaper after Ganty rebuild and couple adjustments, Tension 108hz -110hz

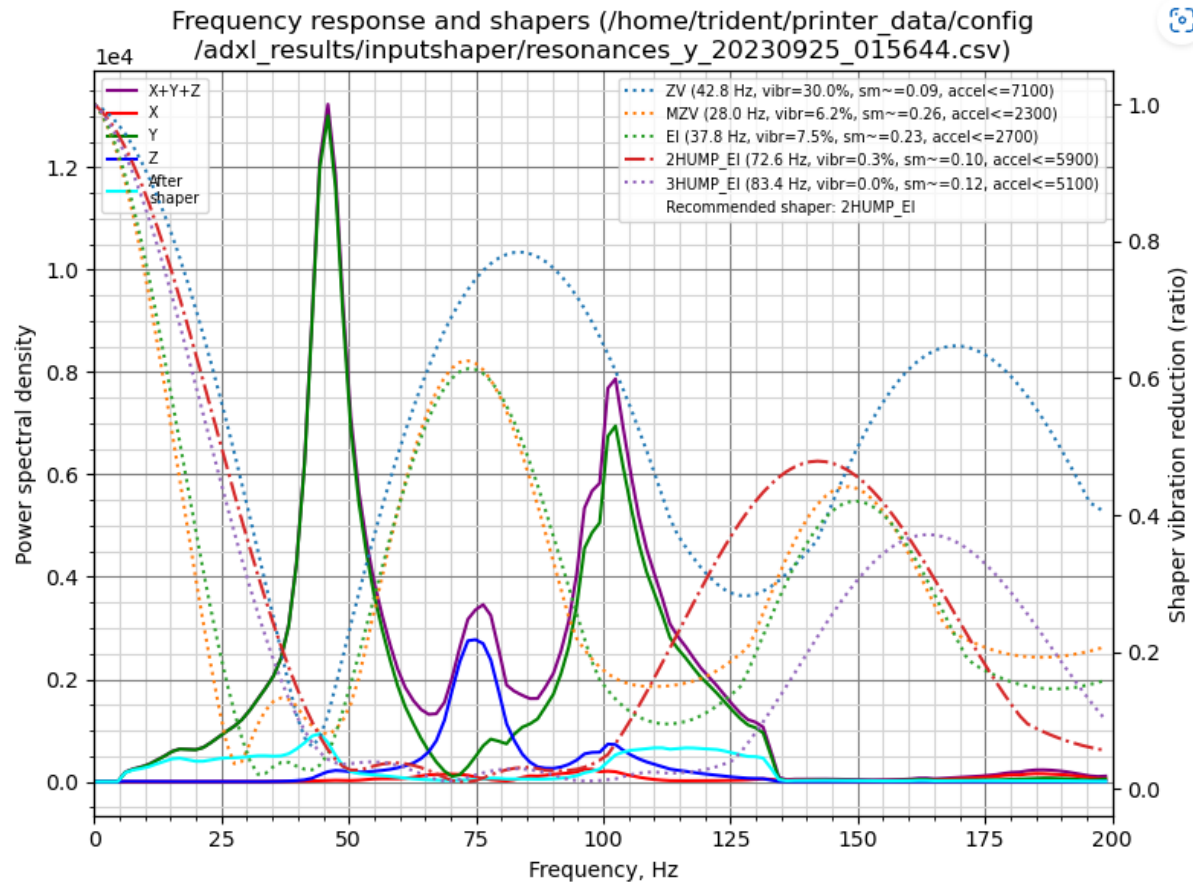
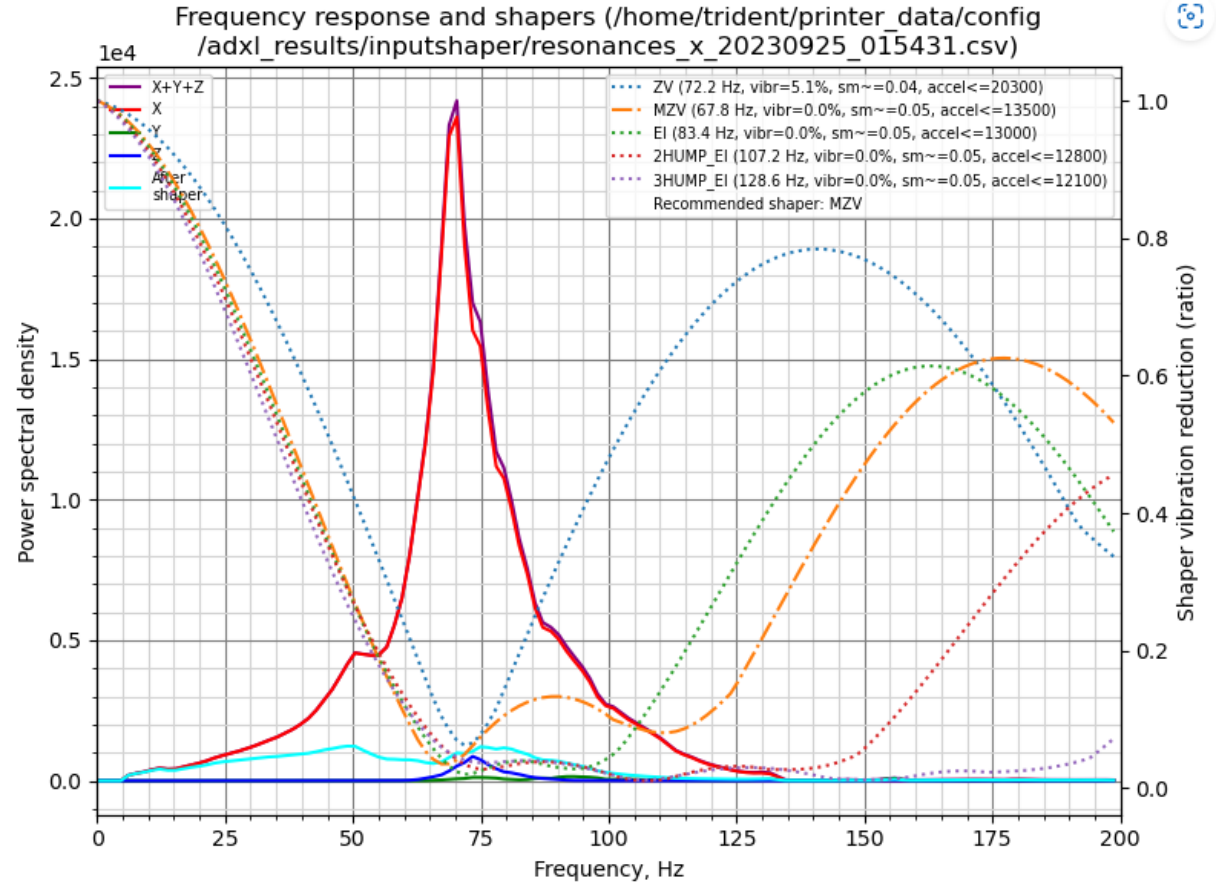
# Not the results I expected on the Y Shaper after the gantry repair.

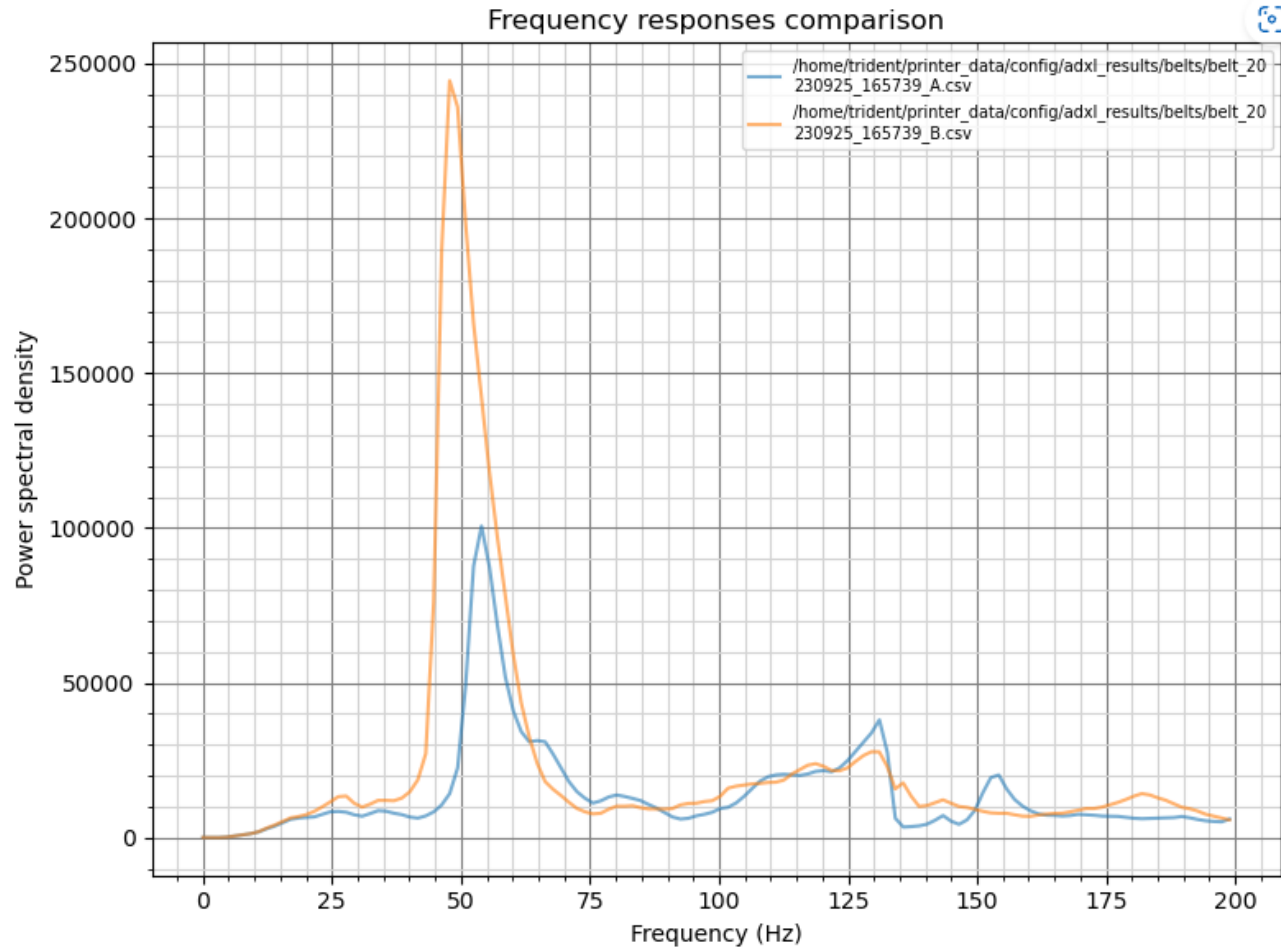
Left –xy joint – belt shaper – bearing/idlers  
are loose

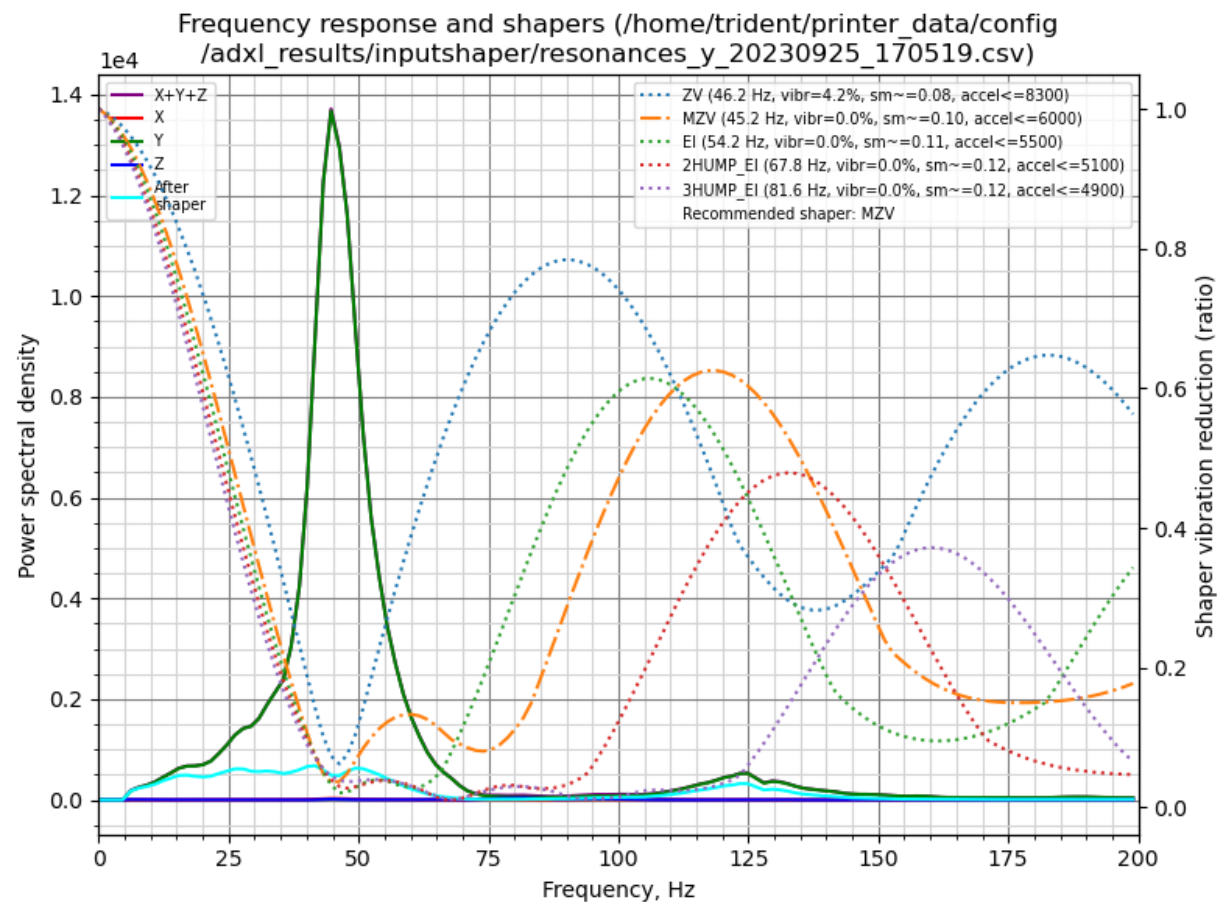
# Left xy-joint y-axis – bearing/idlers are loose

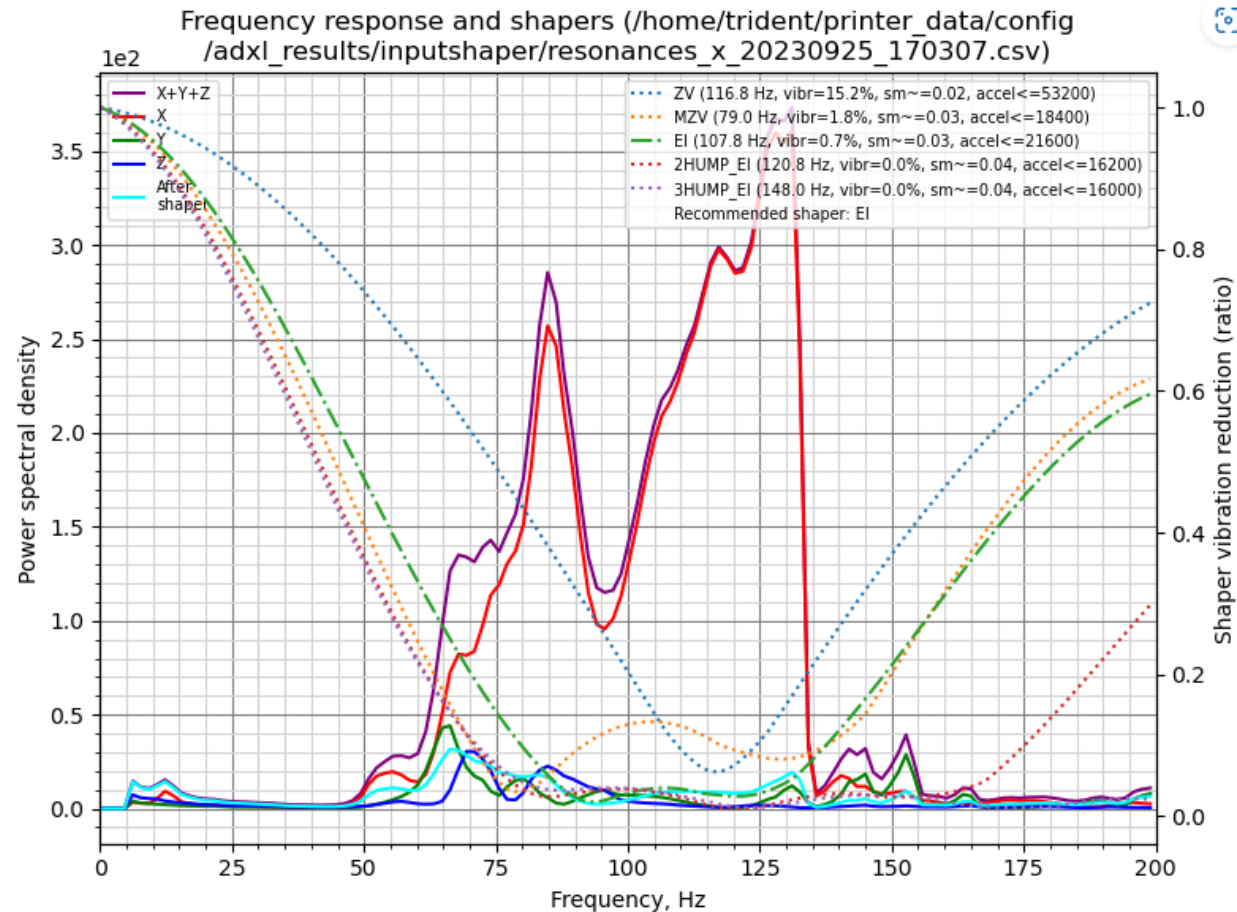
Left –xy joint – x axis – bearing/idlers are loose

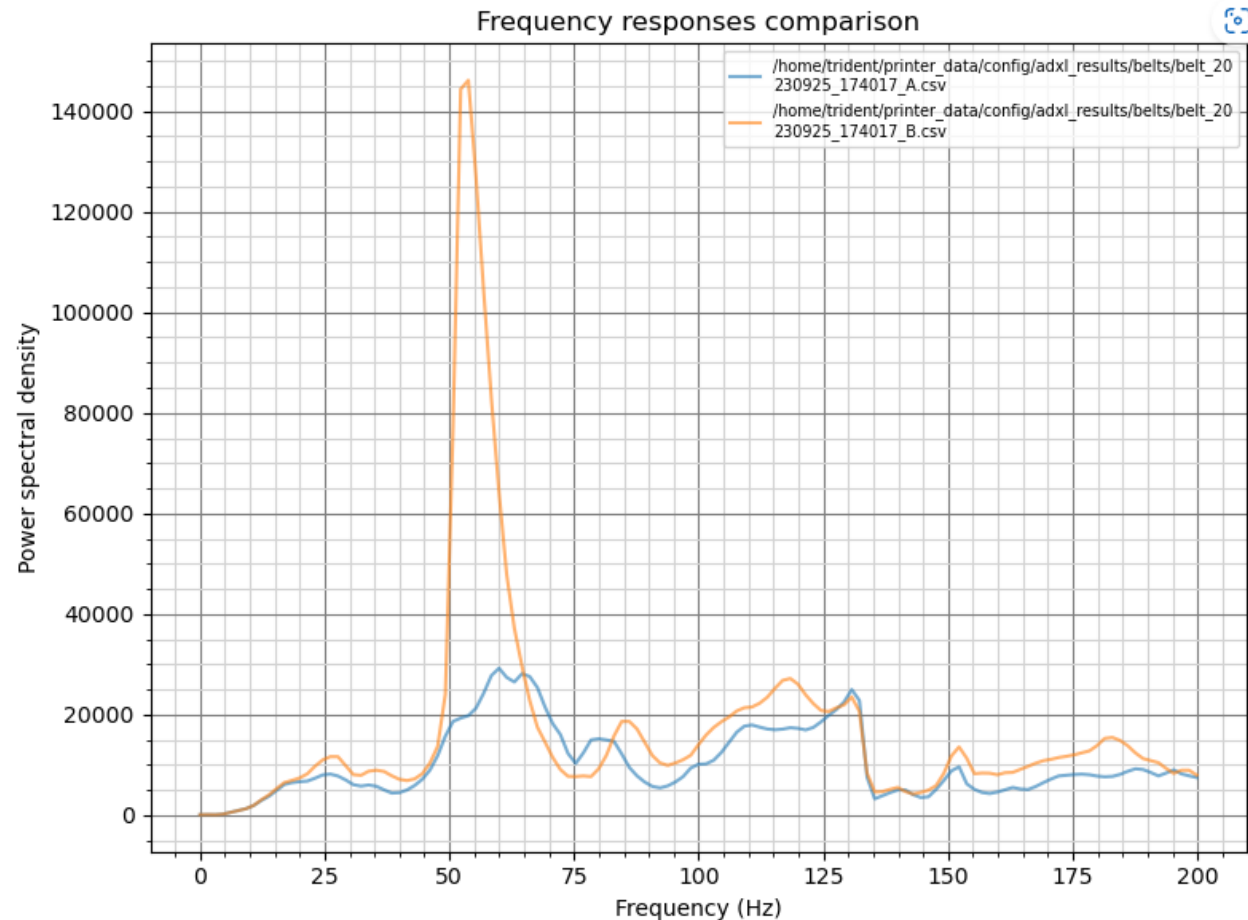
Left –xy joint – belt shaper – bearing/idlers  
are snug

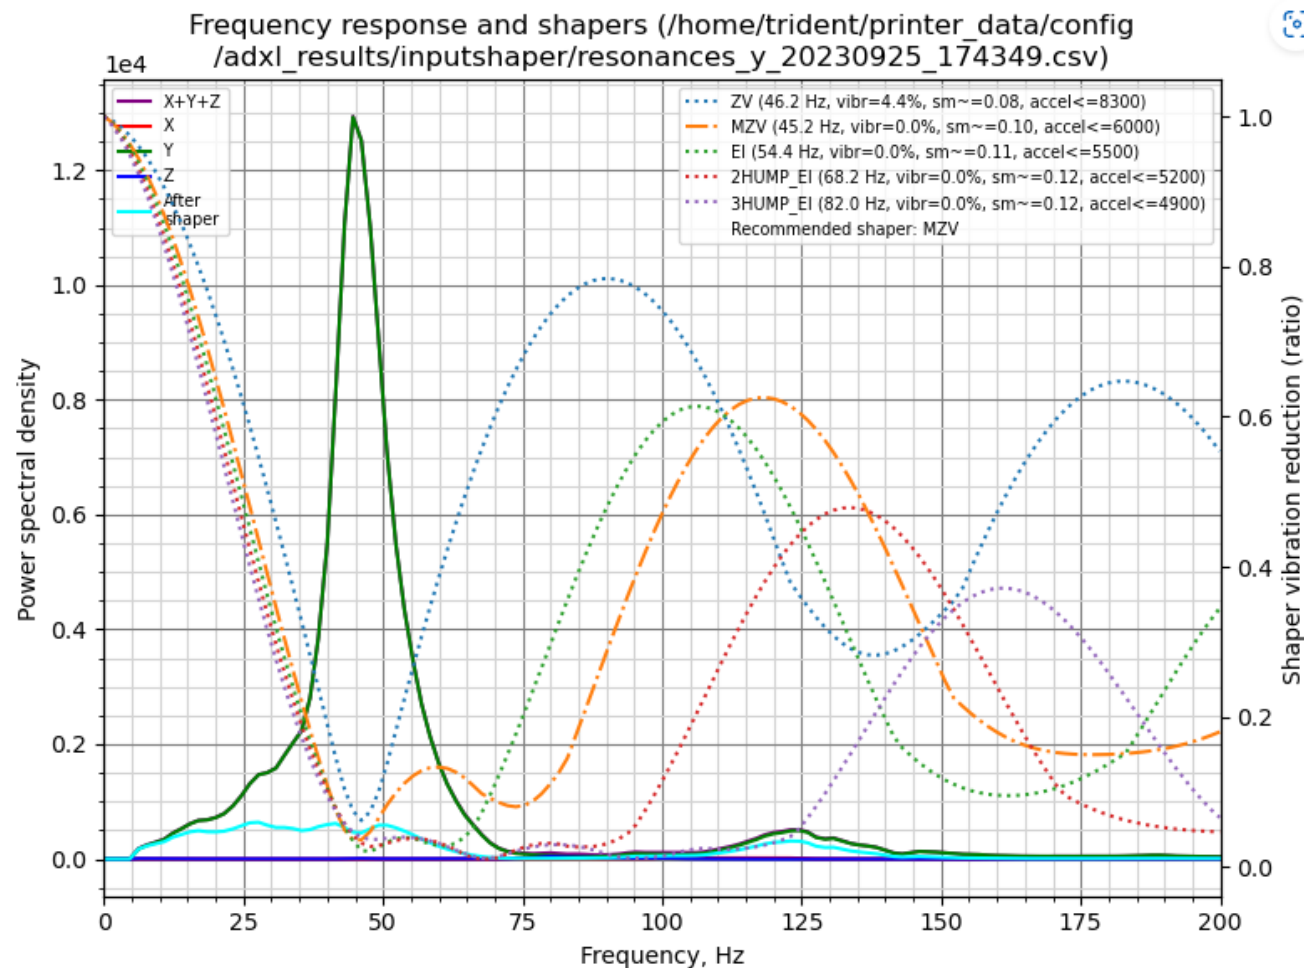
# Left xy-joint y-axis – bearing/idlers are snug

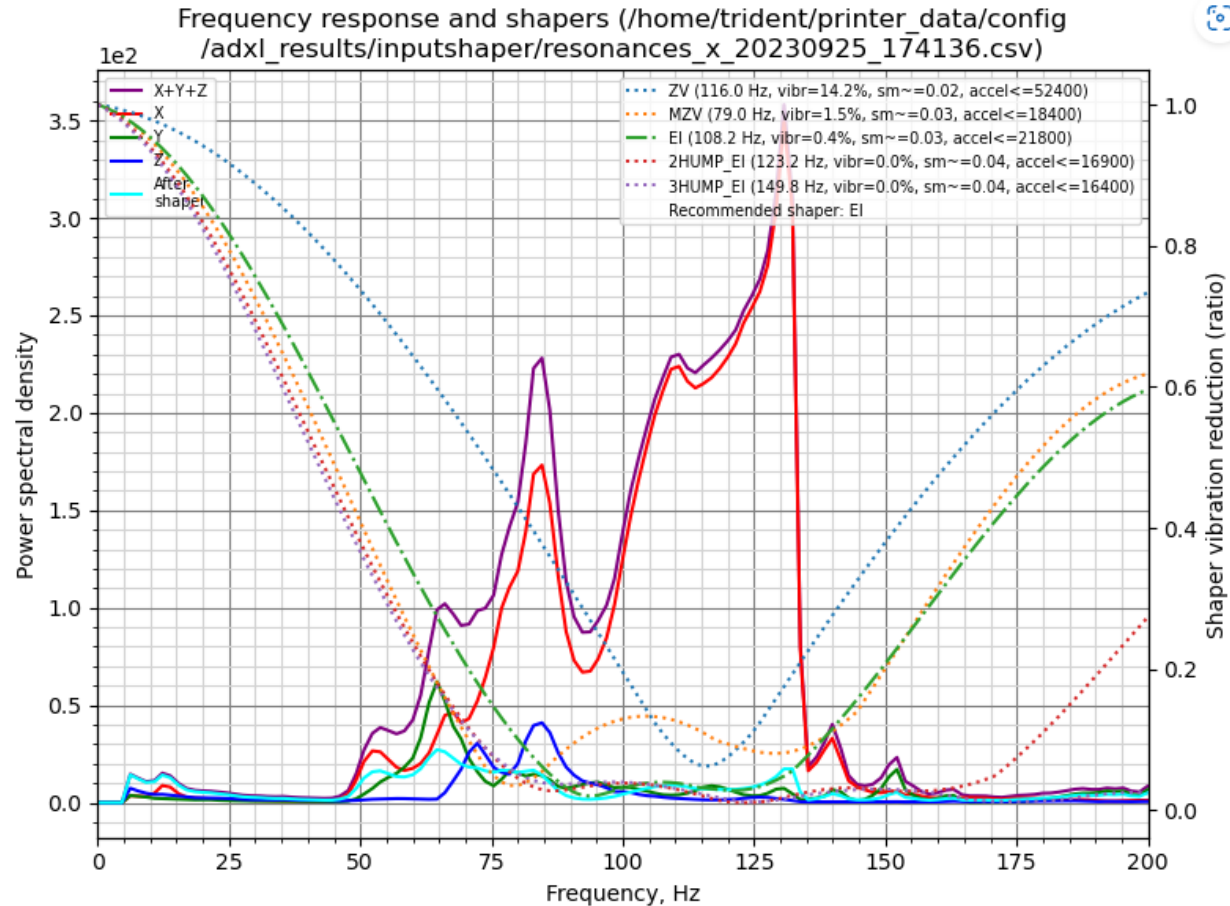
# Left xy-joint x-axis – bearing/idlers are snug

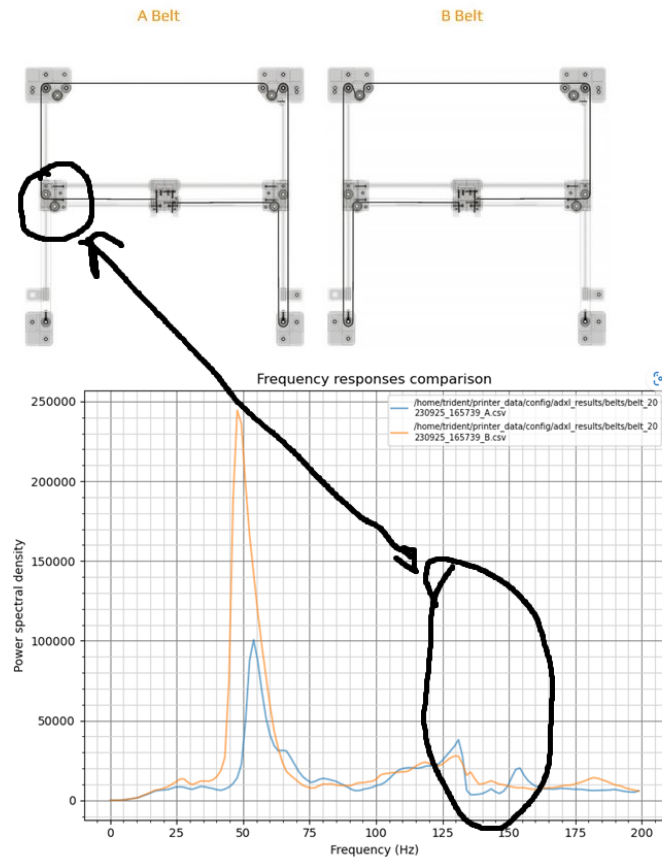
left xy joint

missing second hump

where does this lead us in troubleshooting. What information can be gleam?

Is it the bearings that are bad? Is it the 20tooth idler? Is the extrusion level? Is the linear rail good? Does the linear rail need more lube?

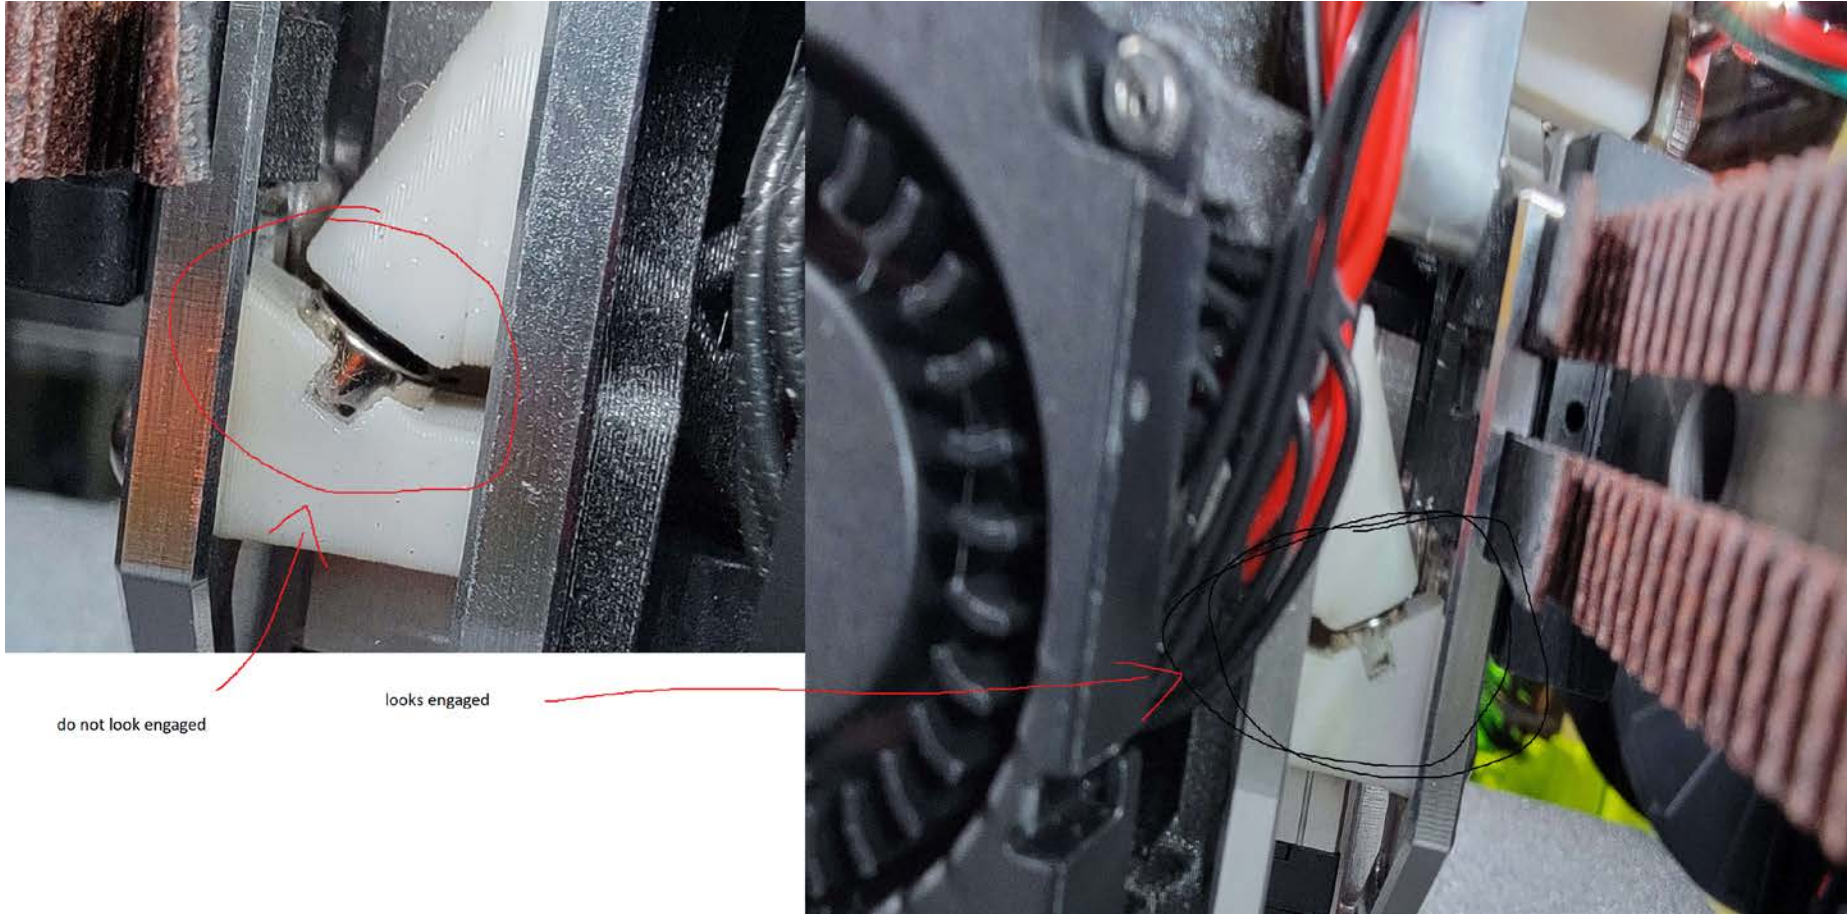
# Magnet on Vitalii tap not properly engaged

Recommendation adjust magnet on left side of printer for vitalii tap

- Einstein states he can put the paper in as the right side of the left magnet only catches on the edge.
- Asked if he could rotate the magnet at all to make it flush
- If he cannot, for testing purposes only, I will ask if he can insert other magnets into the spot so hopefully that will fill the spot

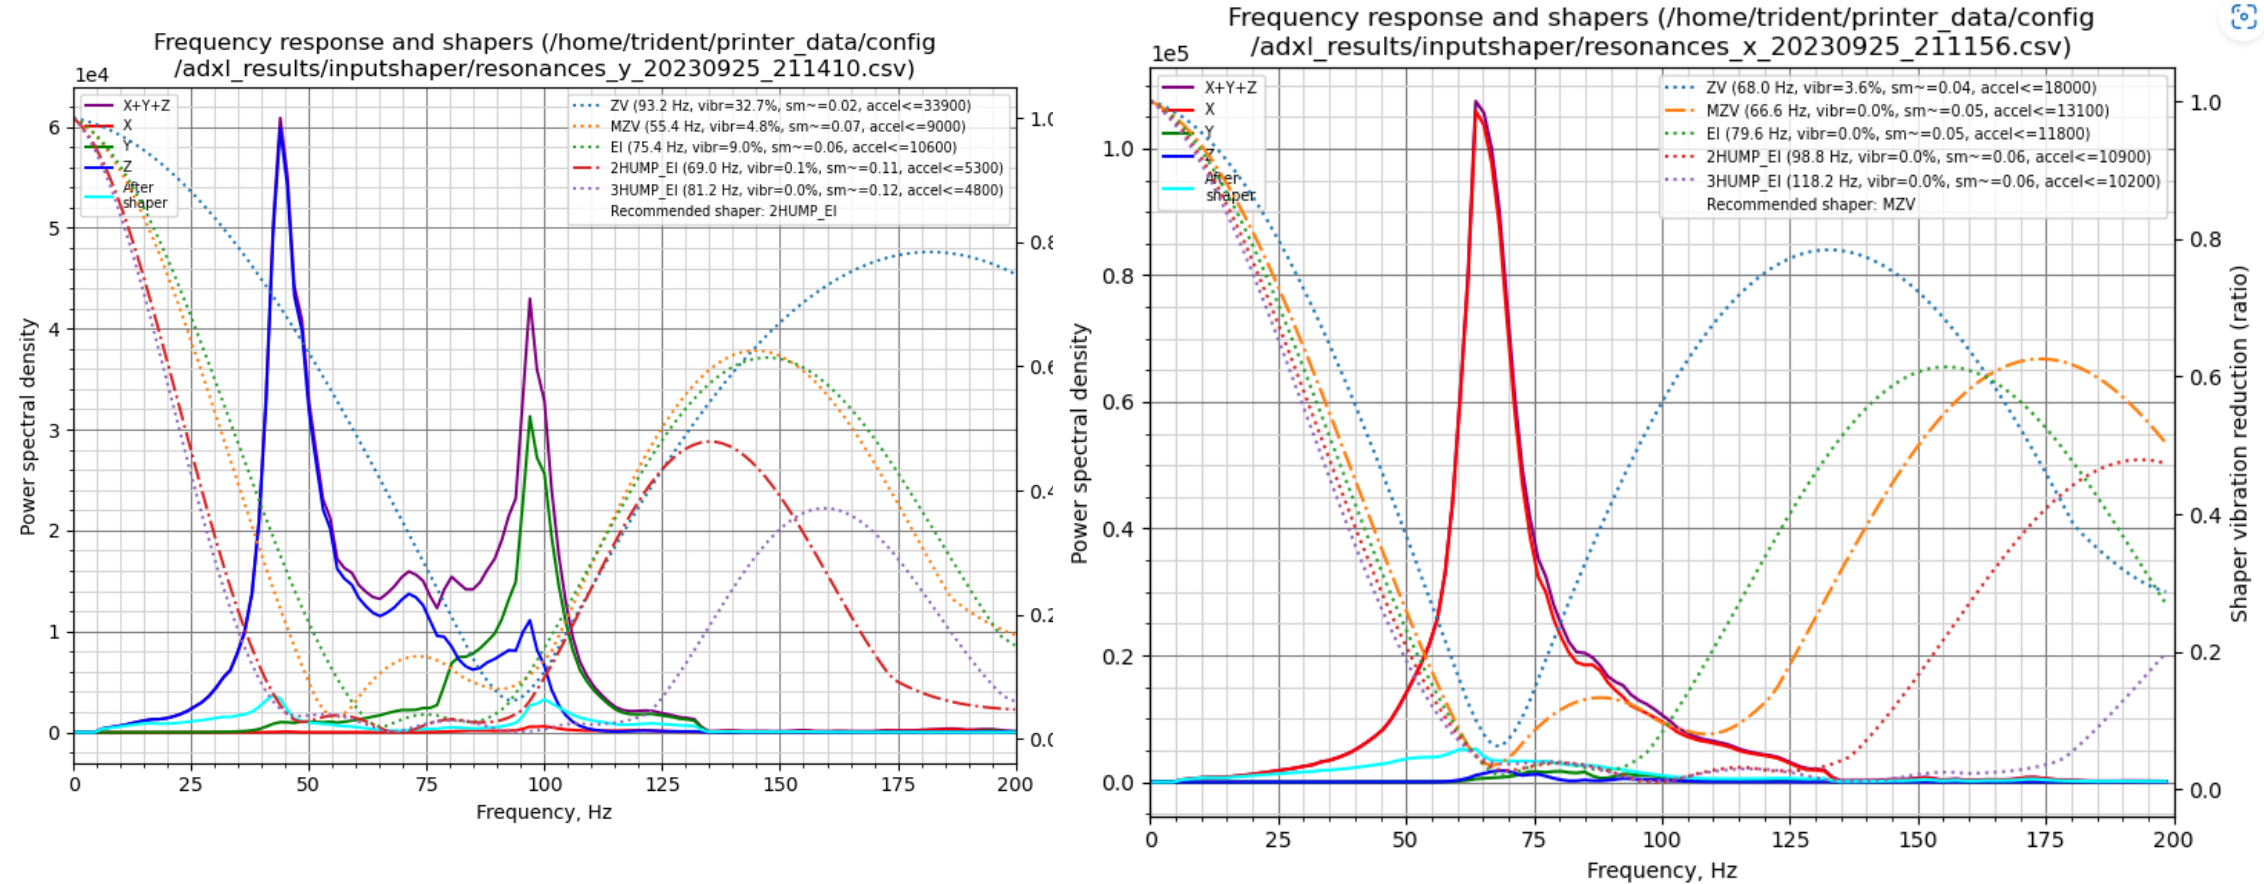
# No change after rotational adjustment to left tap magnet canbus

- Print voron cube
- Remove back cover and inspect belt routing and position on bearings: look for belt dust
- Run input shaper again.
- If this does not work reevaluate
  - Start by redoing belt tension. Loosen all the way and redo
  - Do we need to replace bearings/20 tooth idelers?
  - Do we need to take off toolhead and recheck it?

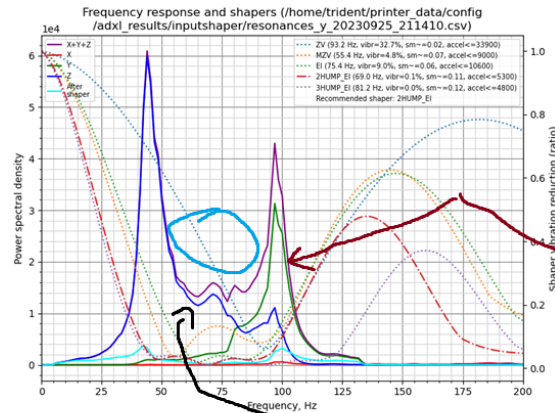
Einstein with Vitalii tap

We see very similar graph the graphs are not the same, but we see that Y makes a peak and then trails off, followed by a z spike

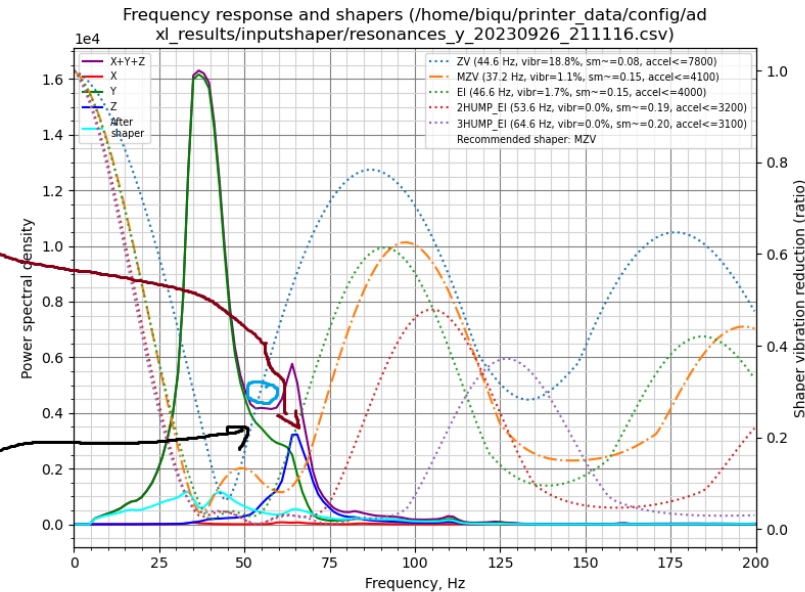
Alex with Vitalii tap

What appears to be different is the blue circled area - the spacing between the y spike and the z spike

however, this may be caused by the same thing. I am receiving a vitalii tap this week I will investigate this

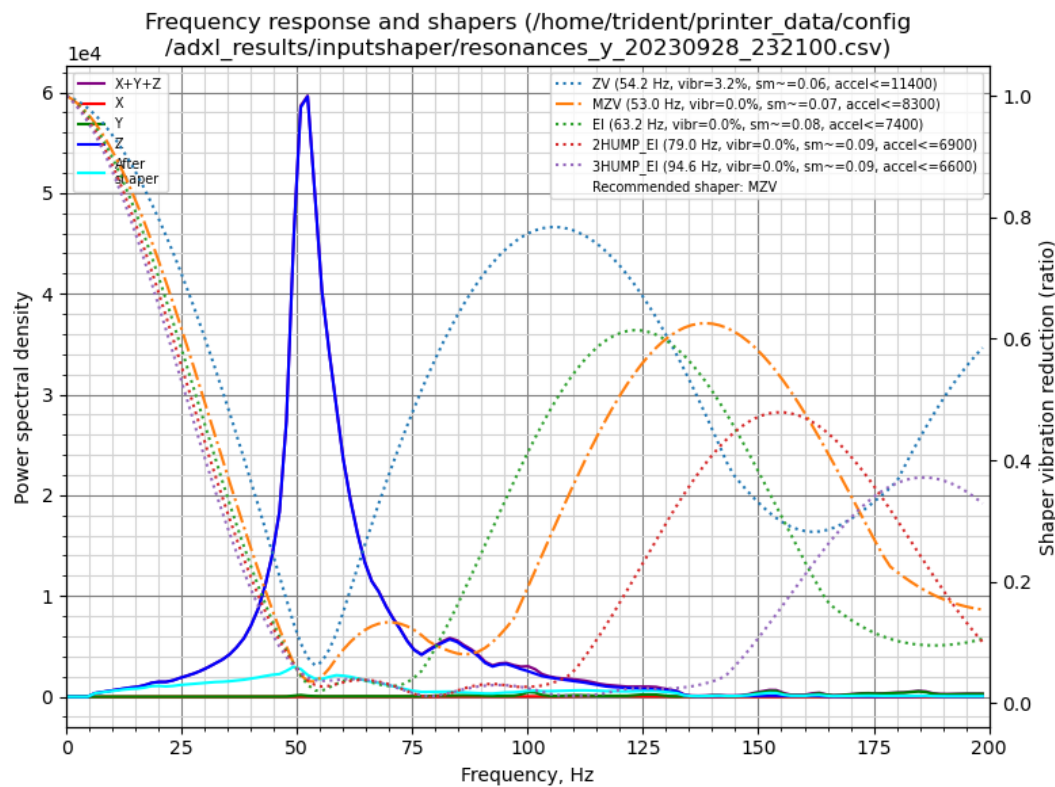
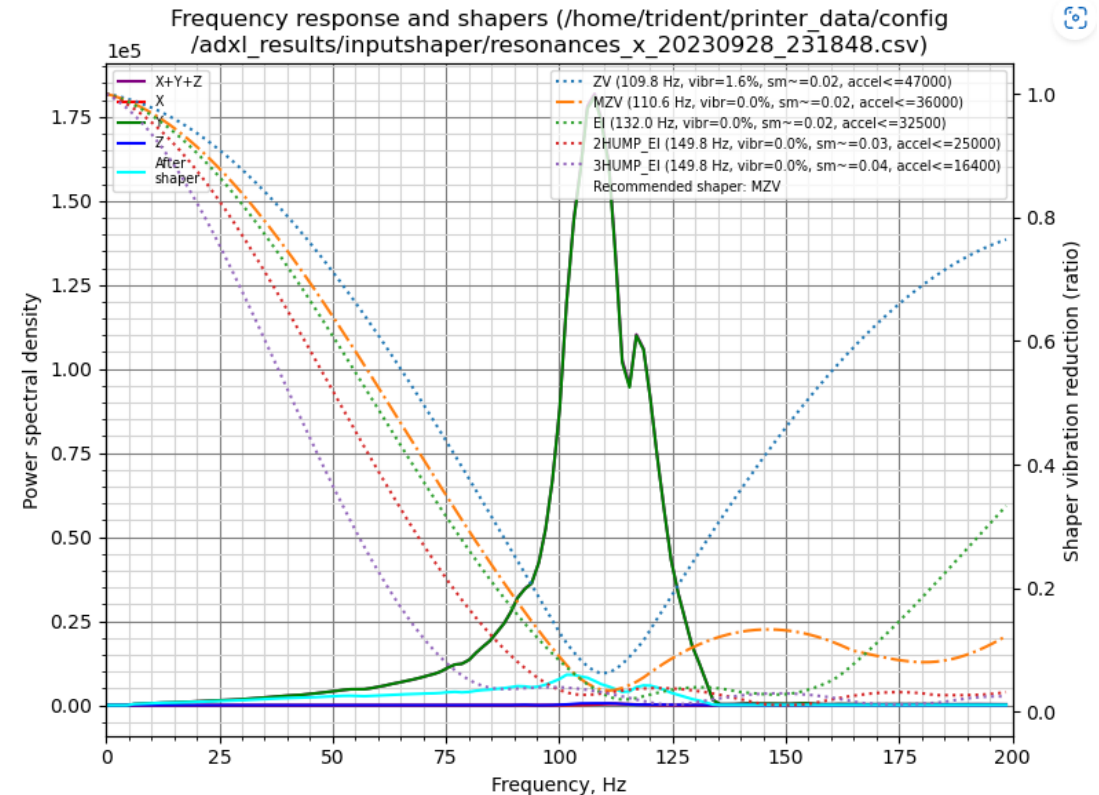
# Results of Input shaper without toolhead

- By putting the adxl directly on the Vitalii tap we have shown through the resulting input shaper graphs that the motion system is solid. We are not getting the 100hz in y.
- What we cannot say is that the x-linear rail is solid. This is because there is no weight on it. However, in the case at hand that is not a real issue as the x-axis input shaper graphs were not an issue.
- Outside testing
  - More testing on this technique needs to happen. This needs to be verified with a known good system. Reth will try to develop a testing platform to determine if this can be a definitive test for testing the motion system to determine toolhead head issue from the rest of the motion system
